Heavy Agricultural Loads on Pavements and Bridges

Sponsored by the
Iowa Department of Transportation and the
Iowa Highway Research Board

March 1999

Iowa DOT Project HR-1073

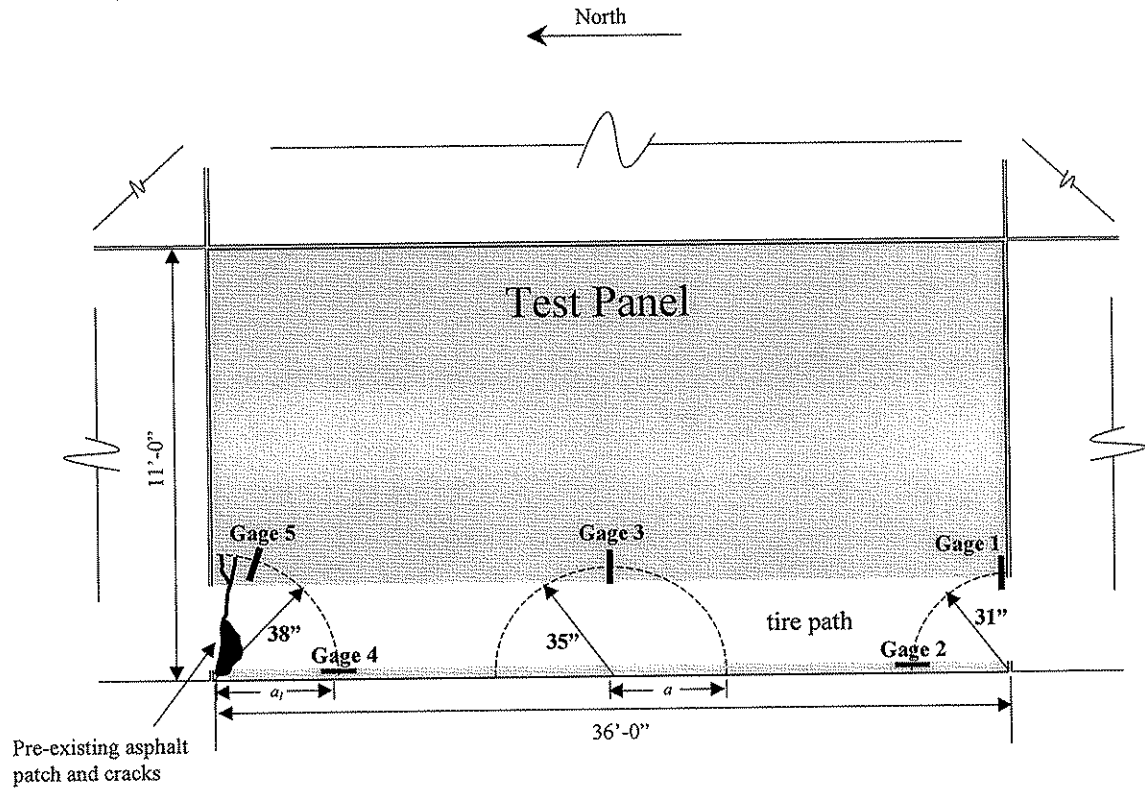
Figure 2. Strain gage layout and loading path on PCC pavement panel.

The pavement strains were measured by strain gages mounted on the panel top surface at locations to obtain maximum levels due to grain cart wheel loads (see Figure 2). Five gages, Hitec Products model HBP-35-2000-C-3VR, were bonded to the concrete using preparation techniques recommended by the Measurements Group, Inc. Tech Tip TT-611. The gages had a gage length of 2 in. and were encapsulated in a protective coating. The adhesive used was M-Bond AE-10, also manufactured by the Measurements Group, Inc. An elevated temperature of 125°F (51.7°C) was applied to the gage simultaneously with a pressure of 10 psi (68.9 kPa) for two hours (Figure 3) while the adhesive cured. After curing was complete, the gages and wires were taped down to the concrete and protected from possible damage and attached to the data acquisition system. Data was collected using an Optim Megadac 5108DC which was controlled by a laptop PC. A scan rate of 50 samples per second was used based on the crawl velocity of approximately 5 mi/h (8 km/h), the speed at which the grain cart test vehicle was to be passed over the test panel.

which is the distance to the point of action of the load on a common angle bisection at the slab corner, is equal to $\sqrt{2}a$. Therefore, the assumed value for locating the gages fell between 30.0 and 38.0 in. (762.0 and 965.2 mm). The final wheel load for the grain cart test vehicle was actually 18,500 lbs. (82.29 kN) and loaded tire pressure was measured at 45 psi (310 kPa). This resulted in an actual a , dimension of 37.2 inches (944.9 cm). The actual positions of Gages 1 through 5 were 31.00, 31.00, 35.00, 38.00 and 37.00 in. (787.4, 787.4, 889.0, 965.2, and 939.8 mm), respectively (Figure 2). These values were chosen in order to provide a range that would include areas of maximum stress. Gages 4 and 5 were positioned closest to the maximum computed stress level. The final layout of the gages is shown in Figure 2.

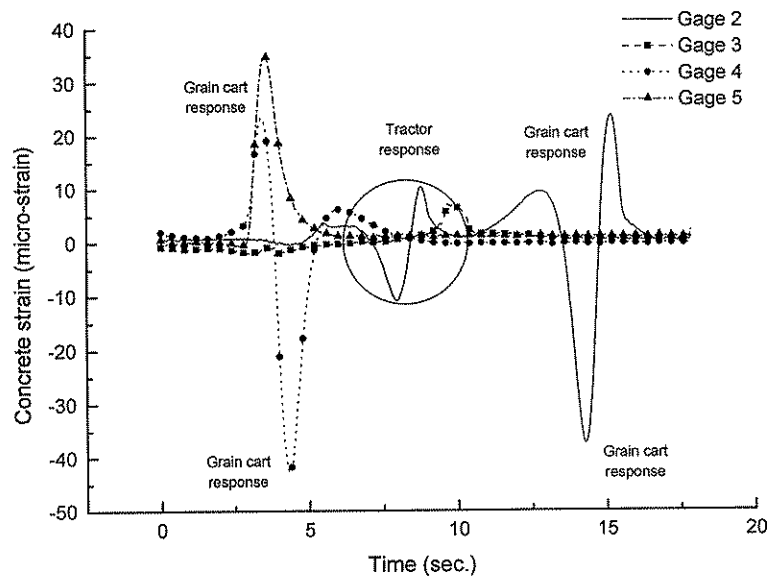
Figure 5. Test 12 strain vs. time plot with cart traveling north to south (left to right)

All of the tests performed indicated similar behavior of the pavement panel. Figure 5 shows a typical strain vs. time plot for one of the tests. There was little difference in the pavement behavior when the cart was pulled either north to south, or pushed south to north. The average maximum reading for Gage 2 was 25 micro-strains in tension and -39 micro-strains in compression. Gage 3 had maximum and minimum averages of 16 micro-strains in tension and -8 micro-strains in compression. Gage 4 average values were 24 micro-strains in tension and -44 micro-strains in compression. Gage 5 average maximum values were 64 micro-strains in tension and -6 micro-strains in compression. Table 1 tabulates these maximum and minimum values along with means and medians for all of the tests. Four of the tests resulted in some higher than normal tension values for Gage 5. The median value for all of the tests on Gage 5 was 44.5 micro-strains in tension. Gage 5 values in tension for, Tests 1, 3, 16, and 27 were 200, 125, 131, and 258 micro-strains. Test 1 plotted data are shown in Figure 6. Similar behavior was recorded in Tests 3, 16 and 27. Maximum stress values were calculated as 900, 562.5, 589.5, and 1,161 psi (6205, 3,878, 4,064, and 8,004 kPa). In general, the stress values in Gage 5 were in the range of 200 psi (1,379 kPa), with the other gage positions showing maximum ranges of 120 psi (827 kPa).

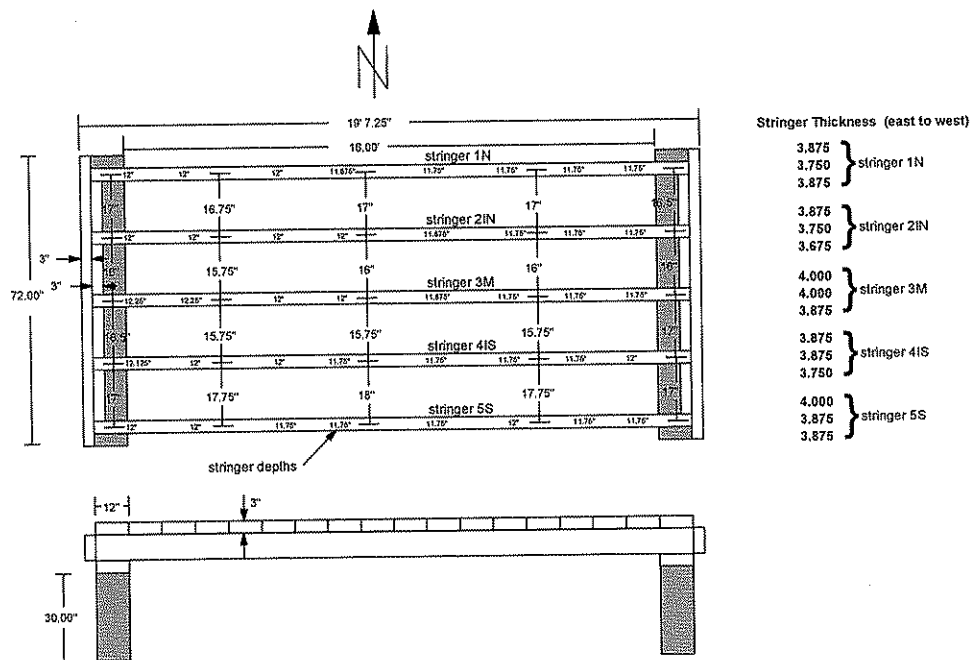
Figure 7. Measured dimensions for Bridge 1.

The bridge was built to the dimensions as shown in Figure 7. The finished bridge is shown in Figure 8. Deflections were recorded at the mid-span of each stringer, and at the support

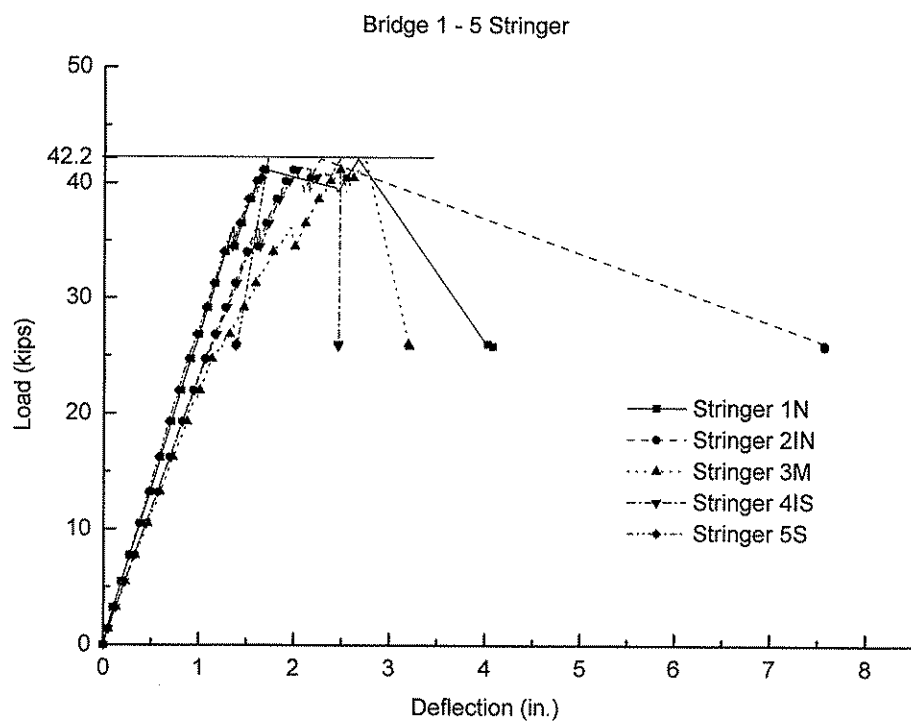
Figure 9. Load/deflection plot of Bridge 1.

of the middle stringer at each end. The accompanying data plot, Figure 9, shows the five mid-span stringer deflections versus the load.
